DAM INSPECTION CHECKLIST POSSUM POINT POWER STATION POND ABC

INSPECTION DATE: JANUARY 5, 2016

INSPECTED BY: K. ACREE

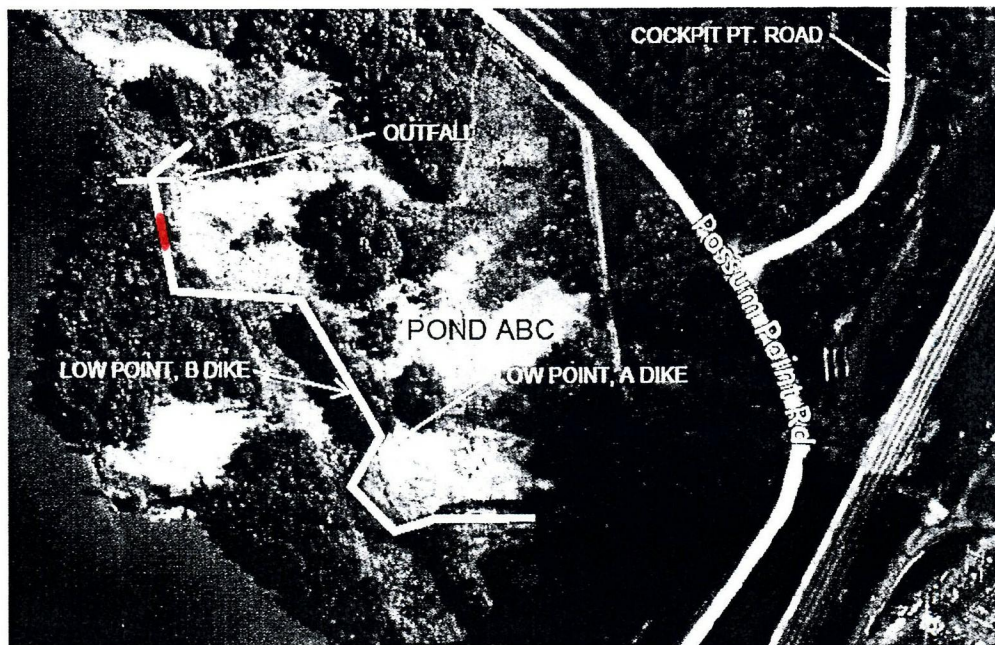
* See figure below.

Location/ Condition	(y/n)	Change (y/n)	Comments
Low Point, A dike*			
Flow	N	N	1130 AM NO WATER AGAINST SANDBAGS
Erosion	N	N	STANDING SAND BAGS IN PLACE WITH SEVERAL RIPPED BAGS RIPRAP IN PLACE
Low Point, B dike*			
Flow	N	N	11:40AM SAND BAGS IN PLACE WITH SEVERAL RIPPED BAGS
Erosion	N	N	NO STANDING WATER AGAINST SAND BAGS
Outfall			
water surface El. (top of stoplogs to water)			NO FLOW AND NO STANDING WATER AGAINST WEIR. ALSO, WEIR WAS ^{IS} DRY, 11:50 AM

Additional Comments (Note any changes observed along the embankment crest or downstream slope observed from the crest.): → STANDING WATER AT TOE OF EMBANKMENT (TYPICAL OF ALL PONDS)

→ STANDING WATER AT TOP OF EMBANKMENT ~~BETWEEN POND~~ AS NOTED BELOW.

→ SAND BAGS AT LOW POINT OF DIKE OF POND C ARE IN PLACE WITH SEVERAL RIPPED BAGS
